**Flood Control Project Maintenance
Levee Inspections**

Maintenance Issue Types Only, Levee Inspection Report By Mile - Spring 2018

Sutter Maintenance Yard Maintenance Area 0017

Waterway	Bank	Unit Miles	Inspection Start/End	Inspector
Unit No. 01 Lake County Sutter Maintenance Yard - Middle Creek	Left	3.87	04/11/2018 04/11/2018	Bob Duffey

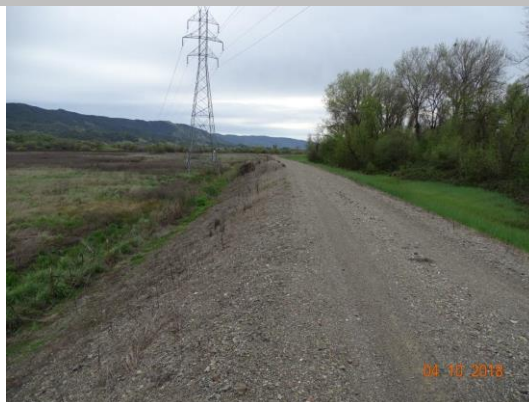
Photo 1 of 1 : SP_2018_MA0017_339_26_20180416_00044.jpg

LM Start	3.60	Rating **	A	Issue No.	26
LM End	3.60	Issue Type +	Ma	Location *	LS
Category	Earthen Levee		GPS Latitude/Longitude		
			Start	End	
Item	Vegetation		39.146885 °	39.146885 °	
			-122.909932 °	-122.909932 °	
DWR ID	DWR_MA0017_01_s_2018_26				
Comment Code					
V1 : Control annual grass and weeds on the levee slopes and easements.					
Inspector Comment					
The vegetation has been removed from the landside slope.

View of the levee with no vegetation on the landside slope.

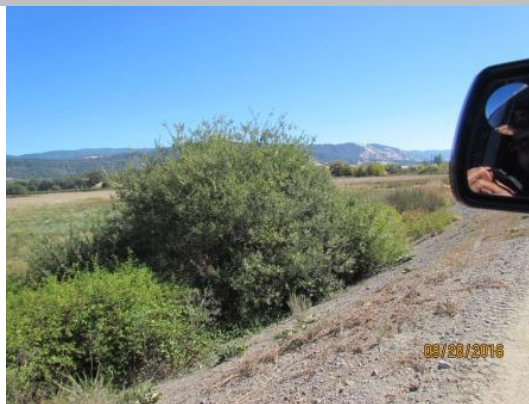
Photo 1 of 1 : SP_2018_MA0017_339_15_20180305_00003.jpg

LM Start	3.81	Rating **	M	Issue No.	15
LM End	3.84	Issue Type +	Ma	Location *	LS
Category	Earthen Levee			GPS Latitude/Longitude	
				Start	End
Item	Vegetation			39.144980 °	39.144620 °
				-122.907073 °	-122.906546 °
DWR ID	DWR_MA0017_01_s_2016_15				
Comment Code					
V2 : Remove the wild growth other than native grasses from the levee slopes.					
Inspector Comment					
Large bushes and brambles covering wire fence, limiting visibility and access.

View of the large bushes limiting visibility and access.

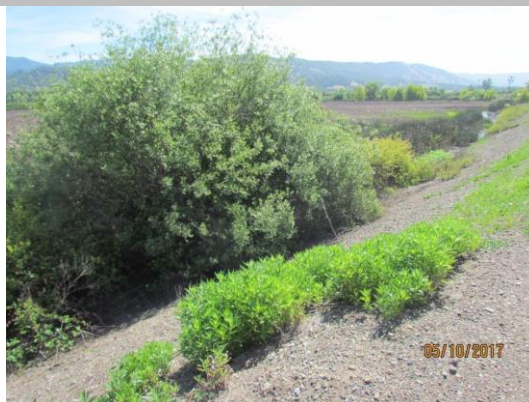
Photo 1 of 1 : SP_2018_MA0017_339_25_20180305_00006.jpg

LM Start	3.84	Rating **	M	Issue No.	25
LM End	3.84	Issue Type +	Ma	Location *	LS
Category	Earthen Levee			GPS Latitude/Longitude	
				Start	End
Item	Trim / Thin Trees			39.144695 °	39.144695 °
				-122.906668 °	-122.906668 °
DWR ID	DWR_MA0017_01_s_2017_25				
Comment Code					
T2 : Thin trees to allow visibility of the ground and room to flood fight.					
Inspector Comment					
Trim the trees along the landside toe.

View of the trees along the landside toe.

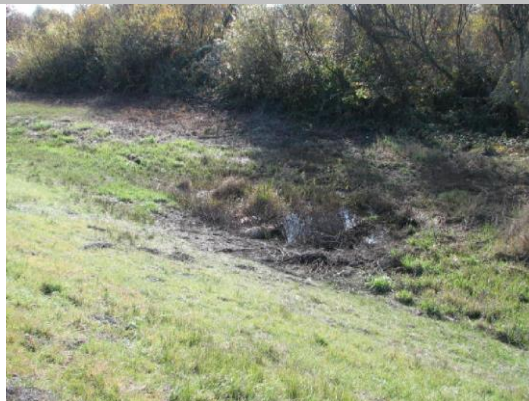
Photo 1 of 3 : UCIP_SP_2018_50814_46849.jpg

FS_ID:50814
DS_ID:844
EP_NO: 11463
Repair Type: No Action Needed
Crossing Status: Found
UCIP Comments: 10/19/2016 Crossing appears to be in good condition.
(DWR Sutter Yard- A Freitag) 6/14/2016 crossing appears to be in good condition. 4/23/2015 No issues with pipe. 7/3/2014 Same as last inspection. 12/23/2013 Same as last inspection. 8/2/2013 New flap gate installed. No other issues with pipe.
FIELD_STRUCT_DESC: 24-inch corrugated metal drainage pipe through the levee, 12.4 feet below the crown. Flap gate on the waterside (WS) end. Timber walkway on the landside (LS) slope to a timber walkway to pump house mounted on piles in drainage ditch. (24-inch pipe [HLM 3.99] authorized under Automatic Board Order (ABO) issued as Permit No. 11463, 1975 - Audrey Jones). [Additional Reference(s): DWR Levee Log, 2005. USACE Sacramento O&M Manual 506.2, August 1961, (HLM 3.99)].
FS Date: 11/21/2016 12:09:38 PM

24-inch CMP at outlet on WS toe.

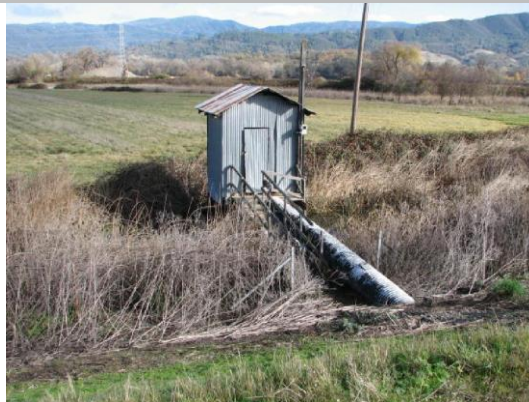
Photo 2 of 3 : UCIP_SP_2018_50814_46848.jpg

Pumphouse on piles at LS toe.

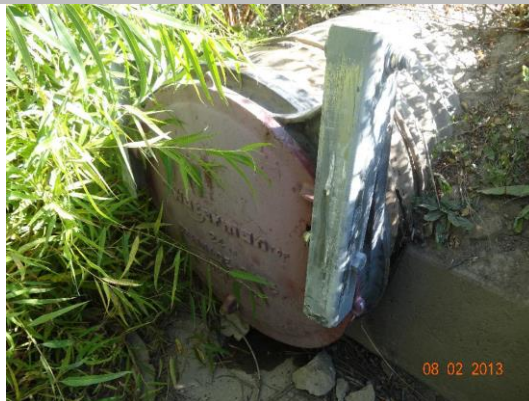
Photo 3 of 3 : UCIP_SP_2018_50814_46850.jpg

New flap gate on WS

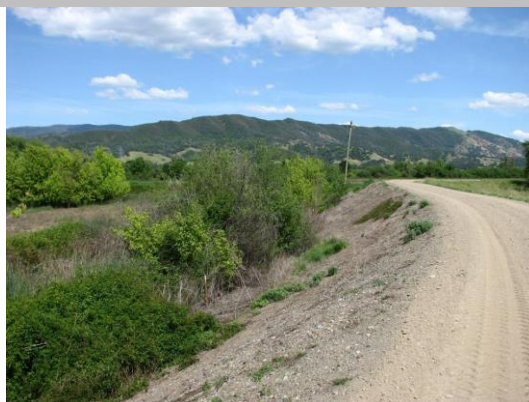
Photo 1 of 1 : SP_2018_MA0017_339_16_20180305_00004.jpg

Large bushes and brambles growing on wire fence on LS toe limiting visibility and access.

V2 : Remove the wild growth other than native grasses from the levee slopes.

5/2/2016: Remove or trim dense vegetation growing on fence to allow visibility and access to L/S toe.

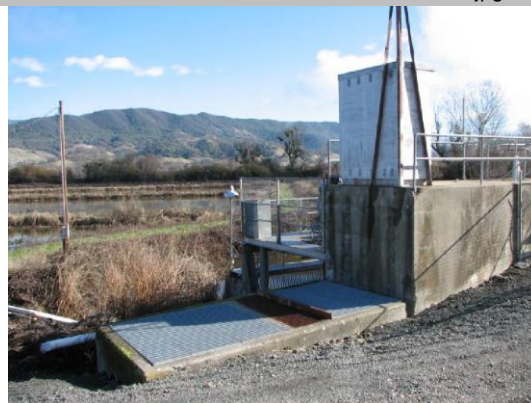
Photo 1 of 3 : UCIP_SP_2018_50815_46853.jpg

FS_ID:50815
DS_ID:845
EP_NO: 11464
Repair Type: No Action Needed
Crossing Status: Found
UCIP Comments: 10/27/2017 This structure is inspected annually under the Structure and Channel Summer Inspection (part of the Levee Inspection Program) conducted by the DWR Flood Project Integrity and Inspection Branch (FPIIB). (DWR UCIP - O. Magana)
10/19/2016 Crossing appears to be in good condition. (DWR Sutter Yard- A Freitag) 6/14/2016 crossing appears to be in good condition. 4/23/2015 No issues with pipe. 7/3/2014 Same as last inspection. 12/23/2013 Same as last inspection. 8/2/2013 Same as last inspection.
FIELD_STRUCT_DESC: [Bloody Island Pumping Plant] 1 of 2: 42-inch corrugated metal drainage pipe through the levee, 20.2 feet below the crown. Concrete headwall and discharge apron on the waterside (WS) shoulder. Three vertical pump units mounted on a reinforced concrete pump platform in drainage ditch at the landside (LS) toe. Flap gates in concrete discharge well on the LS. Combination flap and slide gate on a gravity pipe from drainage ditch into discharge well. (two 42-inch pipes [HLM 4.18] authorized under Automatic Board Order (ABO) issued as Permit No. 11464, 1975 - Lake County). [Additional Reference(s): DWR Levee Log, 2005. USACE Sacramento O&M Manual 506.2, August 1961, (HLM 4.18)].

Pumping Plant on LS shoulder.

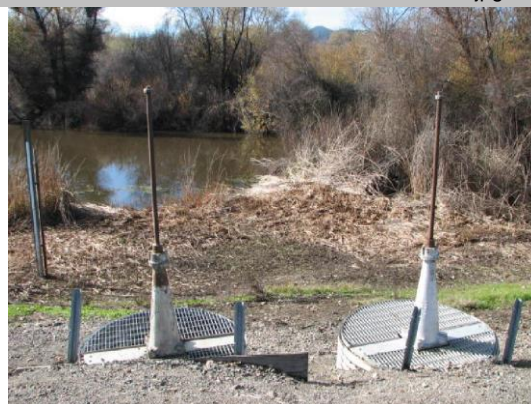
Photo 2 of 3 : UCIP_SP_2018_50815_46852.jpg

Slide gates in CMP risers on WS shoulder.

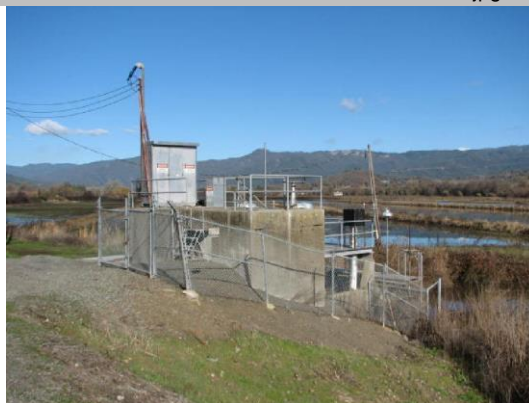
Photo 3 of 3 : UCIP_SP_2018_50815_46851.jpg

Pumping Plant on LS shoulder.

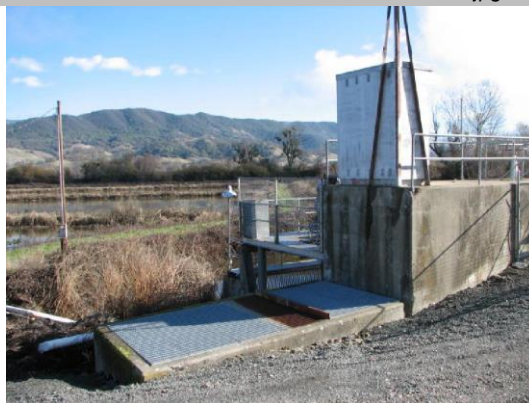
Photo 1 of 3 : UCIP_SP_2018_50816_46856.jpg

FS_ID:50816
DS_ID:852
EP_NO: 11464
Repair Type: No Action Needed
Crossing Status: Found
UCIP Comments: 10/27/2017 This structure is inspected annually under the Structure and Channel Summer Inspection (part of the Levee Inspection Program) conducted by the DWR Flood Project Integrity and Inspection Branch (FPIIB). (DWR UCIP - O. Magana)
10/19/2016 Crossing appears to be in good condition. (DWR Sutter Yard- A Freitag) 6/14/2016 crossing appears to be in good condition. 4/23/2015 No issues with pipe. 7/3/2014 Same as last inspection. 12/23/2013 Same as last inspection. 8/2/2013 Same as last inspection.
FIELD_STRUCT_DESC: [Bloody Island Pumping Plant] 2 of 2: 42-inch corrugated metal drainage pipe through the levee, 14.6 feet below the crown. Concrete headwall and discharge apron on the waterside (WS) shoulder. Three vertical pump units mounted on a reinforced concrete pump platform in drainage ditch at the landside (LS) toe. Flap gates in concrete discharge well on the LS. Combination flap and slide gate on a gravity pipe from drainage ditch into discharge well. (two 42-inch pipes [HLM 4.18] authorized under Automatic Board Order (ABO) issued as Permit No. 11464, 1975 - Lake County). [Additional Reference(s): DWR Levee Log, 2005. USACE Sacramento O&M Manual 506.2, August 1961, (HLM 4.18)].

Pumping plant on LS shoulder.

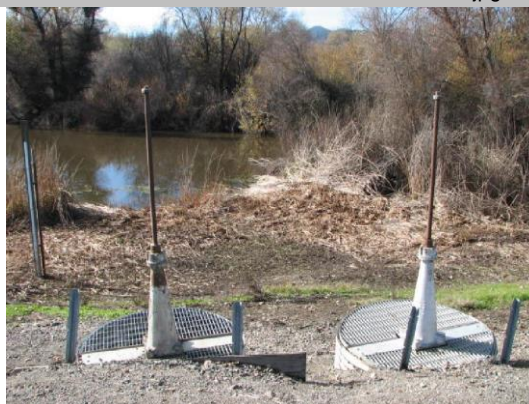
Photo 2 of 3 : UCIP_SP_2018_50816_46855.jpg

Slide gate in CMP riser on WS shoulder.

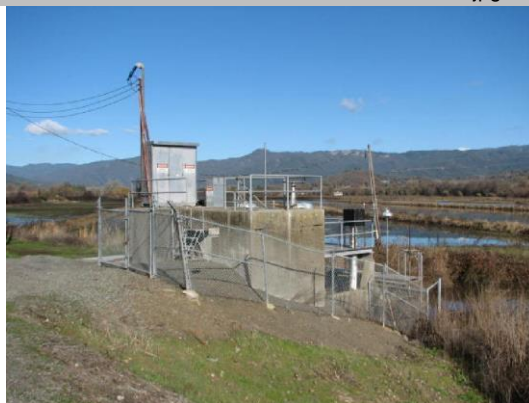
Photo 3 of 3 : UCIP_SP_2018_50816_46854.jpg

Pumping plant on LS shoulder.

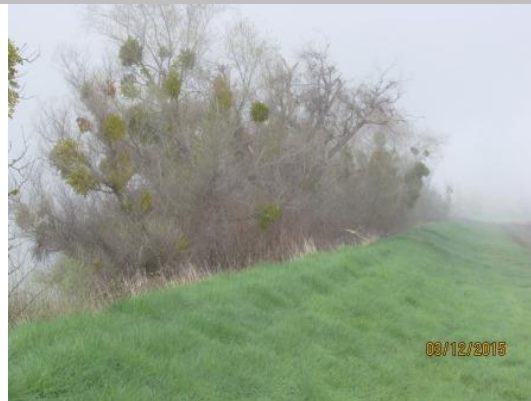
Photo 1 of 2 : SP_2018_MA0017_339_2_20180305_00001.jpg

LM Start	4.16	Rating **	U	Issue No.	2
LM End	7.10	Issue Type +	Ma	Location *	WS
Category	Earthen Levee			GPS Latitude/Longitude	
				Start	End
Item	Trim / Thin Trees			39.141894 °	39.120609 °
				-122.902201 °	-122.887166 °
DWR ID	DWR_MA0017_01_s _ 2012_2				
Comment Code					
T2 : Thin trees to allow visibility of the ground and room to flood fight.					
Inspector Comment					
Trees and limbs are completely obstructing visibility on crown and WS. Crown is too narrow to drive, and overgrown with weeds, brush and trees. Road follows LS toe.

View of the trees along the waterside slope and toe.

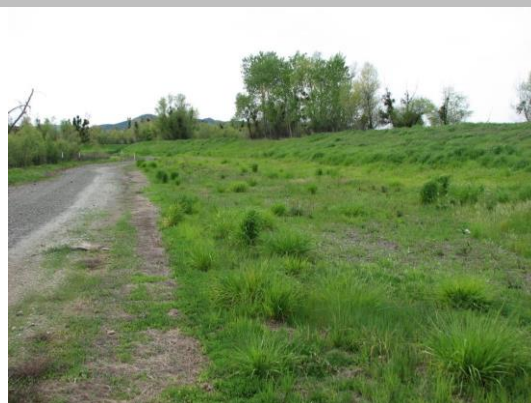
Photo 2 of 2 : SP_2018_MA0017_339_2_20180305_00002.jpg

Photo taken at LM 6.41 looking west showing overgrown LS slope of levee at right and toe road at left. Note trees obstructing visibility and access at levee crown. Crown is +/- 5 feet wide, and impassable to vehicles due to vegetation, and in some places, to pedestrians.

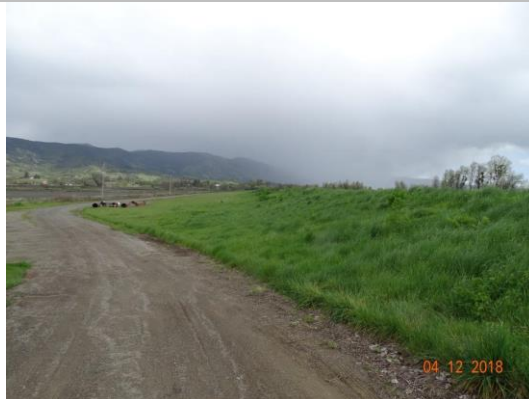
Photo 1 of 1 : SP_2018_MA0017_339_27_20180416_00045.jpg

LM Start	4.55	Rating **	M	Issue No.	27
LM End	7.29	Issue Type +	Ma	Location *	LS
Category	Earthen Levee			GPS Latitude/Longitude	
				Start	End
Item	Vegetation			39.136650 °	39.118672 °
				-122.900850 °	-122.884865 °
DWR ID	DWR_MA0017_01_s_2018_27				
Comment Code					
V1 : Control annual grass and weeds on the levee slopes and easements.					
Inspector Comment					
Remove the native vegetation from the landside slope.

View of the levee with native vegetation over 1 foot tall.

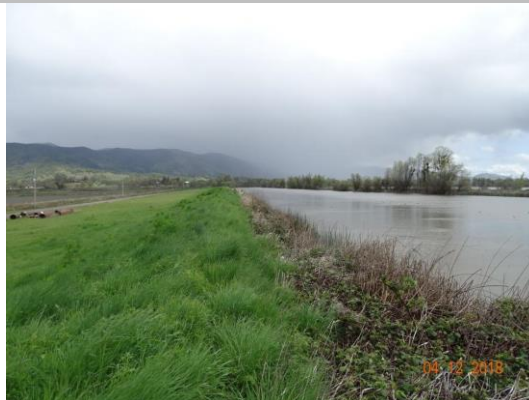
Photo 1 of 1 : SP_2018_MA0017_339_28_20180416_00046.jpg

LM Start	4.55	Rating **	M	Issue No.	28
LM End	7.29	Issue Type +	Ma	Location *	WS
Category	Earthen Levee			GPS Latitude/Longitude	
				Start	End
Item	Vegetation			39.136650 °	39.118672 °
				-122.900850 °	-122.884865 °
DWR ID	DWR_MA0017_01_s_2018_28				
Comment Code					
V1 : Control annual grass and weeds on the levee slopes and easements.					
Inspector Comment					
Remove the vegetation from the crown and waterside slope.

View of the vegetation on the crown and waterside slope.

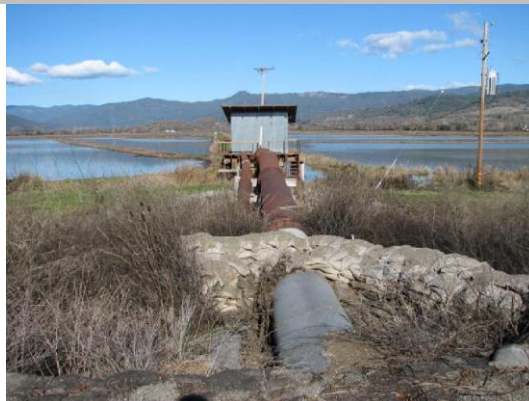
Photo 1 of 2 : UCIP_SP_2018_50818_46860.jpg

FS_ID:50818
DS_ID:847
EP_NO: 11469
Repair Type: Non-Urgent
Crossing Status: Found
UCIP Comments: 10/19/2016 Sack ring still in place. (DWR Sutter Yard- A Freitag) 6/14/2016 Sack ring is still built up underneath the pipes. 4/23/2015 Sack ring is still built up underneath the pipes. 7/3/2014 Same as last inspection. 12/23/2013 Same as last inspection. 8/2/2013 Same as last inspection. 12/13/2012 flood fight materials-ring levees around both LS and WS slopes at pipe crossing. This may or may not be an issue.
FIELD_STRUCT_DESC: 1 of 2: 16-inch steel drainage pipe through the levee, 5 feet below the crown. Drainage pumping plant on the landside (LS). Flap gate on the waterside (WS) end. (one 16-inch and one 36-inch pipes [HLM 5.43] authorized under Automatic Board Order (ABO) issued as Permit No. 11469, 1975 - RD 2070). [Additional Reference(s): DWR Levee Log, 2005. USACE Sacramento O&M Manual 506.3, August 1961, (HLM 5.43)].

Pumping plant, pipes, and ring levees on LS toe.

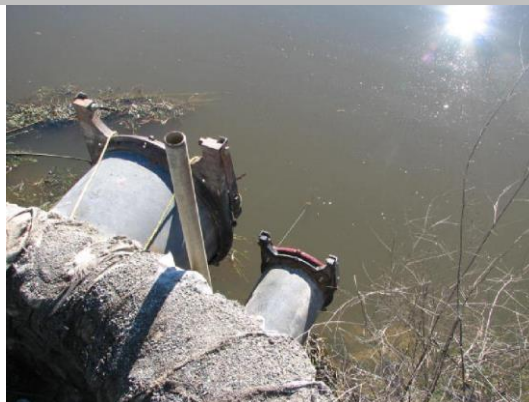
Photo 2 of 2 : UCIP_SP_2018_50818_46859.jpg

16-inch pipe, flap gate, air vent, and ring levee on WS slope.

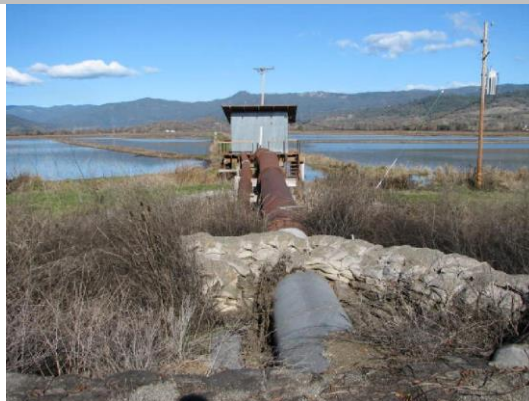
Photo 1 of 2 : UCIP_SP_2018_50819_46864.jpg

FS_ID:50819
DS_ID:853
EP_NO: 11469
Repair Type: Non-Urgent
Crossing Status: Found
UCIP Comments: 10/19/2016 Sack ring still in place. (DWR Sutter Yard- A Freitag) 6/14/2016 Sack ring is still built up underneath the pipes. 4/23/2015 Sack ring still built up underneath the pipes. 7/3/2014 Same as last inspection. 12/23/2013 Same as last inspection. 8/2/2013 Same as last inspection. 12/13/2012 flood fight materials-ring levees around both LS and WS slopes at pipe crossing. This may or may not be an issue.
FIELD_STRUCT_DESC: 2 of 2: 36-inch steel drainage pipe through the levee, 5 feet below the crown. Flap gate and air vent on the waterside (WS) slope. (one 36-inch and one 16-inch pipes [HLM 5.43] authorized under Automatic Board Order (ABO) issued as Permit No. 11469, 1975 - RD 2070). [Additional Reference(s): DWR Levee Log, 2005. USACE Sacramento O&M Manual 506.3, August 1961, (HLM 5.43)].
FS Date: 11/21/2016 12:12:31 PM

Pipes and pump house on LS toe with ring levees.

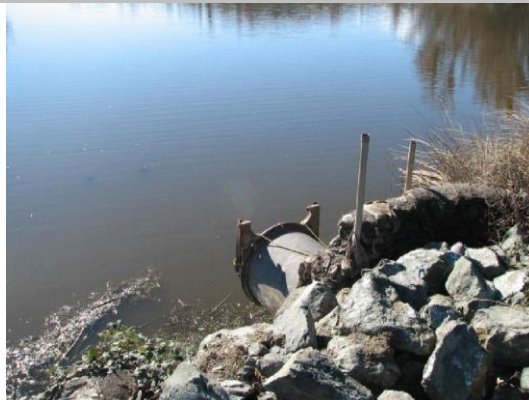
Photo 2 of 2 : UCIP_SP_2018_50819_46863.jpg

Pipe, flap gate, air vent, and sandbags on WS slope.

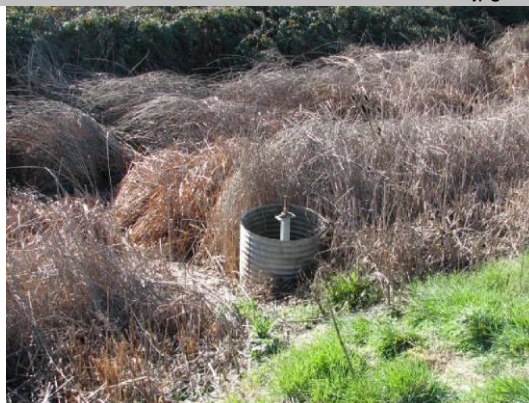
Photo 1 of 2 : UCIP_SP_2018_50820_46866.jpg

FS_ID:50820
DS_ID:848
EP_NO: 11457
Repair Type: Non-Urgent
Crossing Status: Found
UCIP Comments: 10/19/2016 No riser lid or slide gate wheel. (DWR Sutter Yard- A Freitag) 6/14/2016 No riser lid and no wheel to operate screw gate. 4/23/2015 No cover on riser and no wheel to operate gate. 7/3/2014 Same as last inspection. 12/23/2013 Same as last inspection. 8/2/2013 Handle to operate gate was in place but still no cover on riser. 12/13/2012 No cover on CMP riser and no handle for actuating gate. This may or may not be an issue.
FIELD_STRUCT_DESC: 24-inch drainage pipe under patrol road and through the levee, 13.5 feet below the crown. Concrete "U" shaped headwall on the landside (LS) end. Slide gate in 36-inch corrugated metal pipe (CMP) riser on the waterside (WS) slope. Riser unit is mounted on concrete base. (24-inch pipe [HLM 5.87] authorized under Automatic Board Order (ABO) issued as Permit No. 11457, 1975 - Crawford). [Additional Reference(s): DWR Levee Log, 2005. USACE Sacramento O&M Manual 506.3, August 1961, (HLM 5.87)].

36-inch CMP riser and slide gate on WS slope.

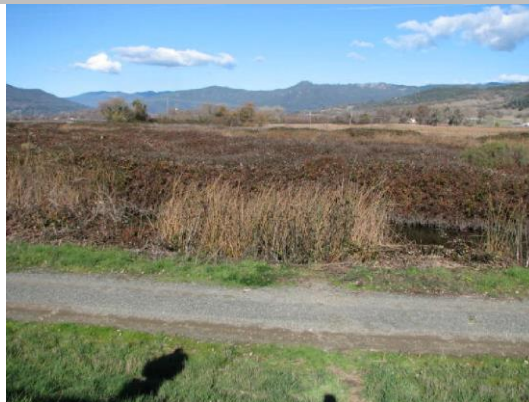
Photo 2 of 2 : UCIP_SP_2018_50820_46865.jpg

Approximate location of inlet on LS toe (not visible).

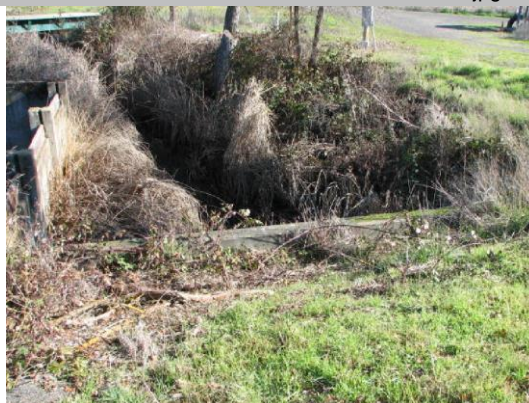
Photo 1 of 3 : UCIP_SP_2018_50821_46869.jpg

FS_ID:50821
DS_ID:849
EP_NO: 11467
Repair Type: No Action Needed
Crossing Status: Found
UCIP Comments: 10/27/2017 This structure is inspected annually under the Structure and Channel Summer Inspection (part of the Levee Inspection Program) conducted by the DWR Flood Project Integrity and Inspection Branch (FPIIB). (DWR UCIP - O. Magana)
10/19/2016 Crossing appears to be in good condition. (DWR Sutter Yard- A Freitag) 6/14/2016 Flap gate propped open. Will make sure its closed before flood season. 4/23/2015 Flap gate propped open. Not an issue at this time. Will close it before high water season. 7/3/2014 Same as last inspection. 12/23/2013 Same as last inspection. 8/2/2013 Same as last inspection.
FIELD_STRUCT_DESC: [Highland Canal Diversion Weir and Drainage] 1 of 2: 54-inch corrugated metal drainage pipe through the levee 11.5 feet below the crown. Highland Canal Diversion Weir and Drainage Structure on the landside (LS). Concrete headwall on both landside (LS) and waterside (WS) toe with flap gate on the WS toe. (two 42-inch pipes [HLM 6.05] authorized under Automatic Board Order (ABO) issued as Permit No. 11467, 1975 - Modglin). [Additional Reference(s): DWR Levee Log, 2005. USACE Sacramento O&M Manual 506.3, August 1961, (HLM 6.05)].

Concrete weir/dam and channel on LS toe.

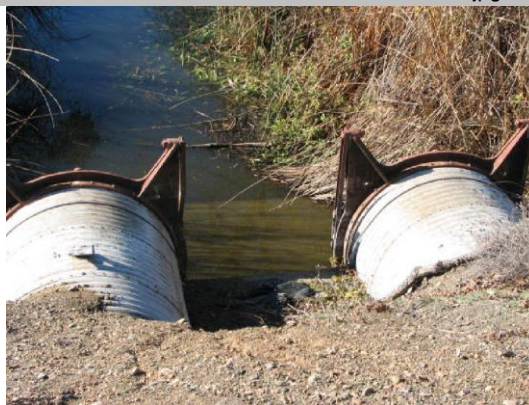
Photo 2 of 3 : UCIP_SP_2018_50821_46868.jpg

pipe and flap gate on WS toe.

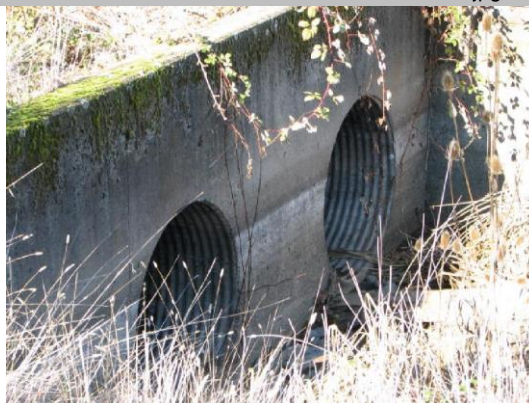
Photo 3 of 3 : UCIP_SP_2018_50821_46867.jpg

Concrete headwall at inlet on LS toe.

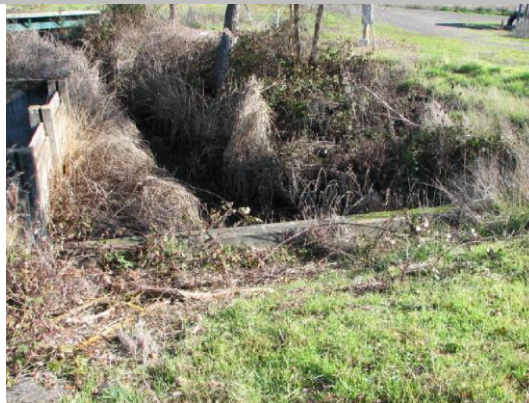
Photo 1 of 3 : UCIP_SP_2018_50822_46872.jpg

FS_ID:50822
DS_ID:854
EP_NO: 11467
Repair Type: No Action Needed
Crossing Status: Found
UCIP Comments: 10/27/2017 This structure is inspected annually under the Structure and Channel Summer Inspection (part of the Levee Inspection Program) conducted by the DWR Flood Project Integrity and Inspection Branch (FPIIB). (DWR UCIP - O. Magana)
10/19/2016 Crossing appears to be in good condition. (DWR Sutter Yard- A Freitag) 6/14/2016 Flap gate propped open. Will make sure its closed before flood season. 4/23/2015 Flap gate propped open. Not an issue at this time. Will close it before high water season. 7/3/2014 Same as last inspection. 12/23/2013 Same as last inspection. 8/2/2013 Same as last inspection.
FIELD_STRUCT_DESC: [Highland Canal Diversion Weir and Drainage]
2 of 2: 54-inch corrugated metal drainage pipe through the levee, 11.5 feet below the crown. Highland Canal Diversion Weir and Drainage Structure on the landside (LS). Concrete headwall on both landside (LS) and waterside (WS) toe with flap gate on the WS toe. (two 42-inch pipes [HLM 6.05] authorized under Automatic Board Order (ABO) issued as Permit No. 11467, 1975 - Modglin). [Additional Reference(s): DWR Levee Log, 2005. USACE Sacramento O&M Manual 506.3, August 1961, (HLM 6.05)].

Concrete dam/weir and channel on LS toe.

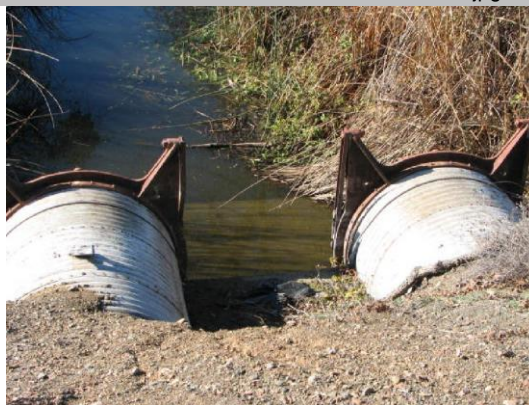
Photo 2 of 3 : UCIP_SP_2018_50822_46871.jpg

Pipe and flap gate on WS toe.

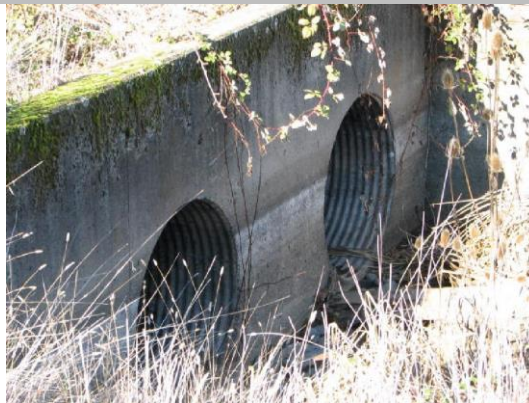
Photo 3 of 3 : UCIP_SP_2018_50822_46870.jpg

Concrete headwall on LS toe.

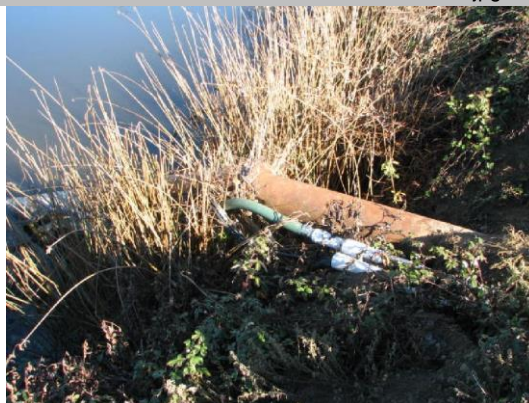
Photo 1 of 3 : UCIP_SP_2018_50826_46882.jpg

FS_ID:50826
DS_ID:850
EP_NO: 11467
Repair Type: Urgent
Crossing Status: Found
UCIP Comments: 10/19/2016 WS erosion still present. (DWR Sutter Yard - A Freitag) 6/14/2016 WS erosion is still present. (DWR Sutter Yard - A Freitag) 4/23/2015 Same as last inspection. (DWR Sutter Yard - A Freitag) 7/3/2014 Same as last inspection. (DWR Sutter Yard - A Freitag) 12/23/2013 Same as last inspection. (DWR Sutter Yard - A Freitag) 8/2/2013 Same as last inspection. (DWR Sutter Yard - A Freitag) 12/13/2012 This pipe and appurtenances do not match what was described in the permit (PN: 11467). Does not appear to be in compliance with board regulations. (DWR UCIP - W Wylie)
FIELD_STRUCT_DESC: 12-inch steel drainage pipe through the levee, 2 feet below the crown. Butterfly valve on the landside (LS) shoulder. Pump and electrical panel, along with multiple valves and appurtenances, on the LS shoulder. (12-inch pipe [HLM 6.11] authorized under Automatic Board Order (ABO) issued as Permit No. 11467, 1975 - B. F. Modglin). [Additional Reference(s): DWR Levee Log, 2005. USACE Sacramento O&M Manual 506.3, 1967, (HLM 6.11)].

12-inch pipe and appurtenances on WS shoulder.

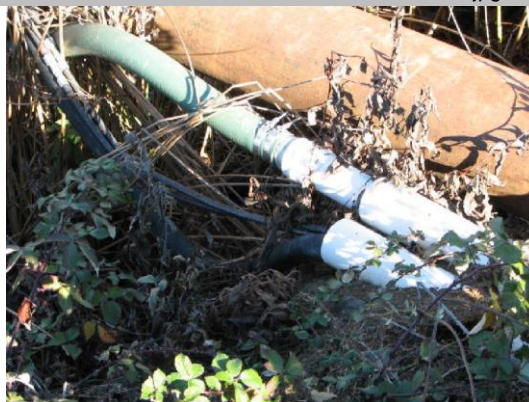
Photo 2 of 3 : UCIP_SP_2018_50826_46881.jpg

12-inch pipe and appurtenances on WS shoulder.

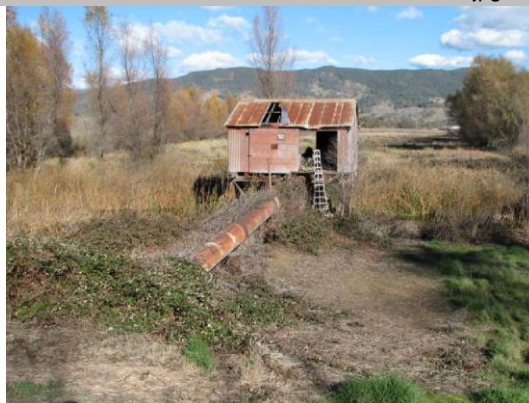
Photo 1 of 2 : UCIP_SP_2018_50827_46884.jpg

FS_ID:50827
DS_ID:851
EP_NO: 11467
Repair Type: Non-Urgent
Crossing Status: Found
UCIP Comments: 10/19/2016 Abandoned- should be done so properly.
(DWR Sutter Yard- AFreitag)6/14/2016 Abandoned crossing.4/23/2015 Same as last inspection. Pipe still needs to be properly abandoned.7/3/2014 Same as last inspection.12/23/2013 Same as last inspection.8/2/2013 Same as last inspection.12/13/2012 Pipe should be properly abandoned.
FIELD_STRUCT_DESC: *ABANDONED* 1 of 2: 16-inch steel drainage pipe through the levee, 8 feet below the crown. Drainage pumping plant on the landside (LS). Flap gate on the waterside (WS) end. Steel plate welded on end of pipe at LS toe. (one 16-inch and one 24-inch pipes [HLM 7.79] authorized under Automatic Board Order (ABO) issued as Permit No. 11467, 1975 - Modglin). [Additional Reference(s): DWR Levee Log, 2005. USACE Sacramento O&M Manual 506.3, August 1961, (HLM 7.19)].
FS Date: 11/21/2016 12:16:52 PM

Pumping plant in shed on LS at drainage ditch.

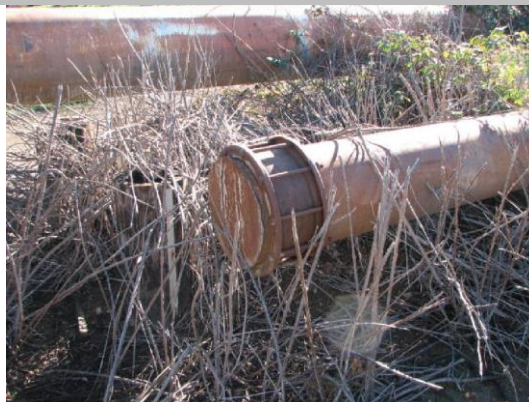
Photo 2 of 2 : UCIP_SP_2018_50827_46883.jpg

Steel plate welded over end of pipe at LS toe.

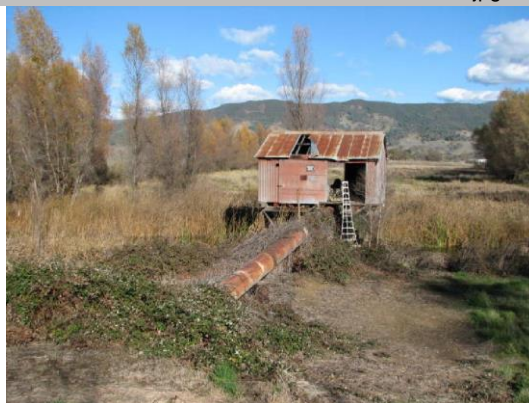
Photo 1 of 2 : UCIP_SP_2018_50828_46886.jpg

FS_ID:50828
DS_ID:855
EP_NO: 11467
Repair Type: No Action Needed
Crossing Status: Found
UCIP Comments: 10/19/2016 Crossing appears to be in good condition. (DWR Sutter Yard- AFreitag)6/14/2016 Crossing appears to be in good condition.4/23/2015 No issues seen with pipe.7/3/2014 Same as last inspection.8/2/2013 Same as last inspection.12/23/2013 Same as last inspection.
FIELD_STRUCT_DESC: 2 of 2: 24-inch steel drainage pipe through the levee, 8 feet below the crown.
Drainage pumping plant on the landside (LS). Flap gate on the waterside (WS) end. (one 16-inch and one 24-inch pipes [HLM 7.79] authorized under Automatic Board Order (ABO) issued as Permit No. 11467, 1975 - Modglin). [Additional Reference(s): DWR Levee Log, 2005. USACE Sacramento O&M Manual 506.3, August 1961, (HLM 7.19)].
FS Date: 11/21/2016 12:17:36 PM

24-inch steel pipe and pump house on LS.

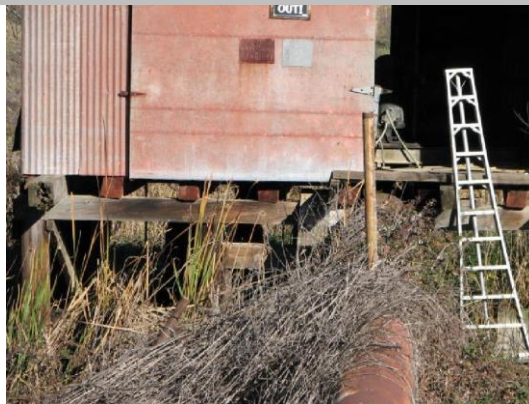
Photo 2 of 2 : UCIP_SP_2018_50828_46885.jpg

Air vent on pipe at LS pumphouse.
